SAND REPORT

SAND2004-4083
Unlimited Release
Printed August 2004

Failure Analysis and Surety Design of Composite Patching Systems

Dr. Sameer Hamoush)

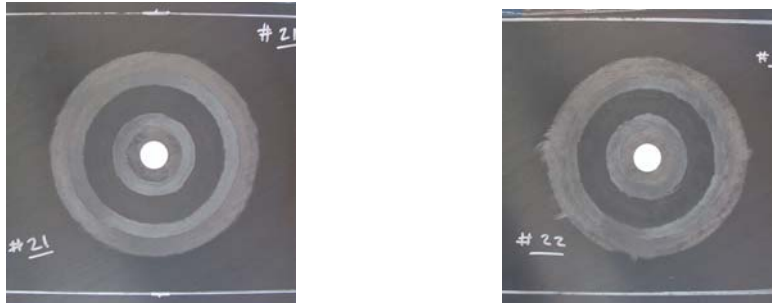
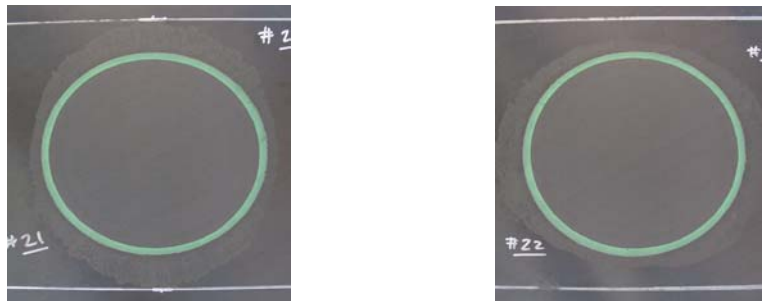
Figure 2. Scarfed and Repaired Panels

Figure 2.a Scarfed panels (# 21 and 22)

Figure 2.b Repaired panels

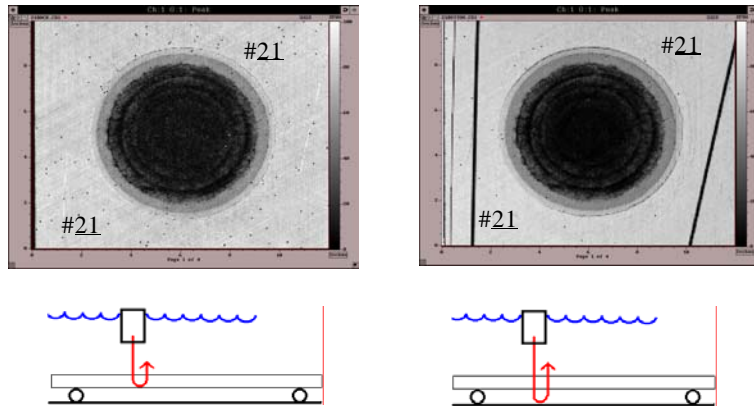
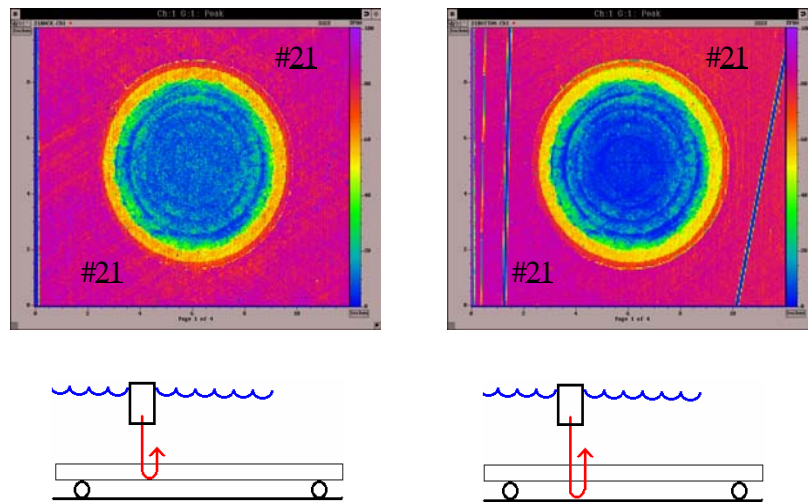
Figure 3 NDT scan of patched panels

The repaired panels were shipped to Iowa State University's Center for Nondestructive Evaluation Airworthiness Assurance Center of Excellence for NDT evaluation that is to ensure the soundness of the repair. The NDT C-scan is shown in Figure 3. The images shown in Figure 3 indicate good repairs without any apparent flaws.

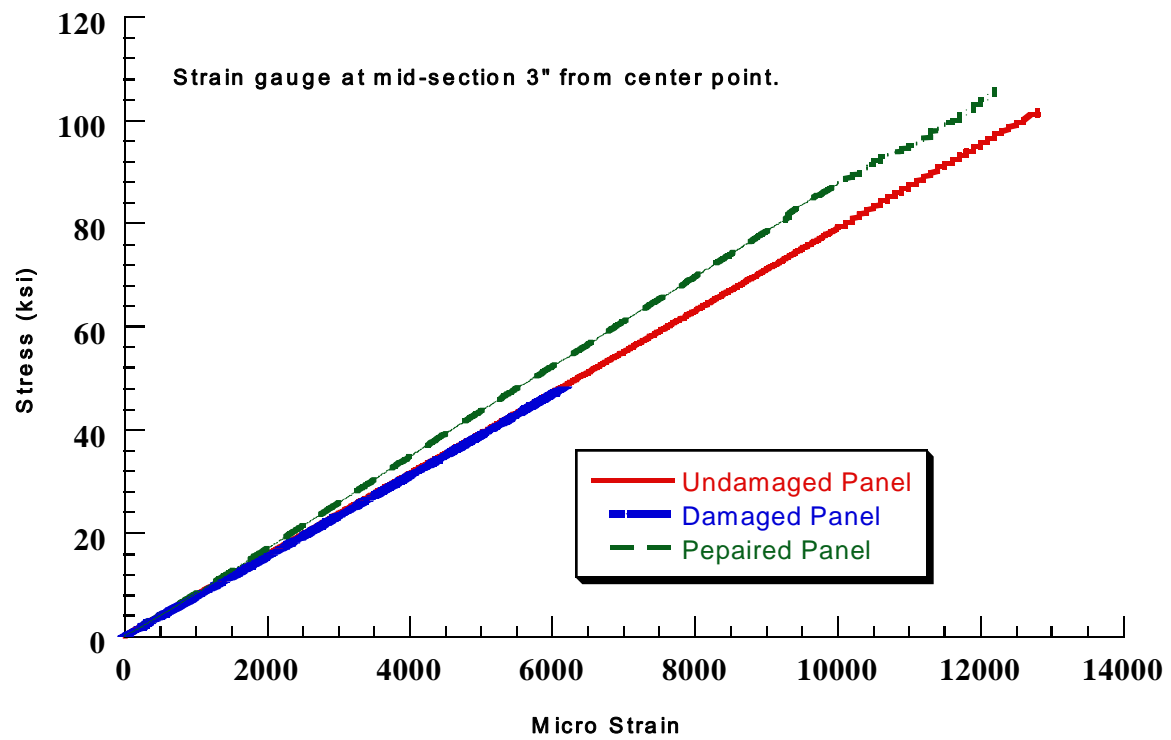
Figure 6: Comparison between strain gauges on the three panel types.

The stress-strain behavior shown in Figure 6 indicates that the patch increases the stiffness of the panel in comparison with the pristine panel.

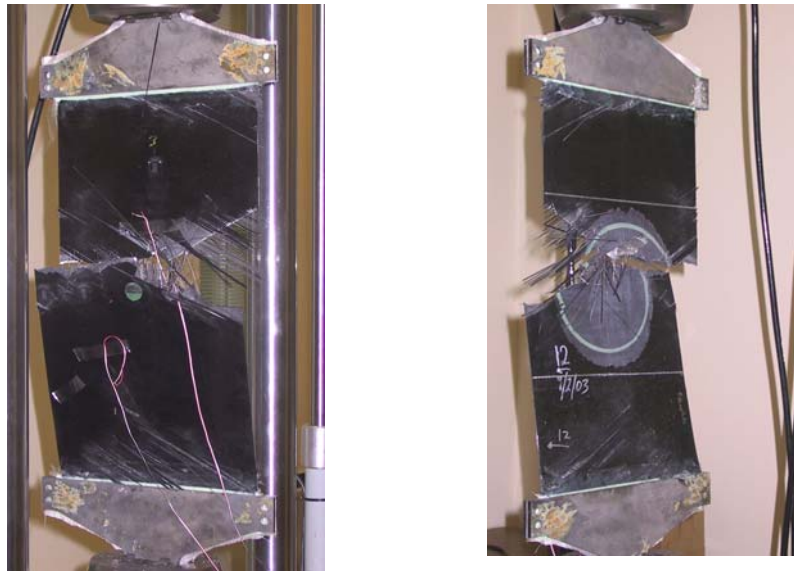
Figure 7: Failed repaired Specimen.

Figure 7 shows that the failure in the repaired panel took place at mid-section of the specimen.
